GENUINE PARTS

INSTALLATION INSTRUCTIONS

G9911 1KM0A II Rev. 07/30/2010

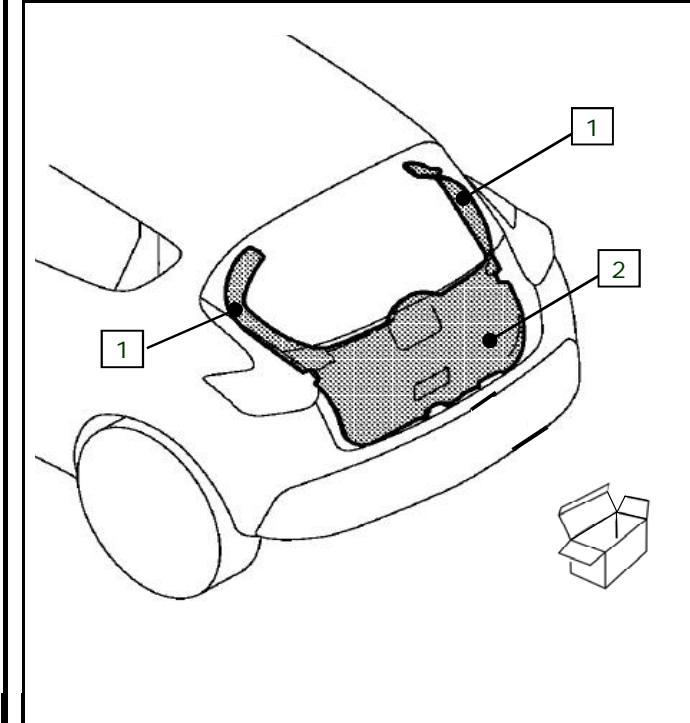
1.Back door side trim(RH/LH) 2.Back door trim Fig. 1

1) Remove the following vehicle parts in the sequence shown below.

Remove Sequence

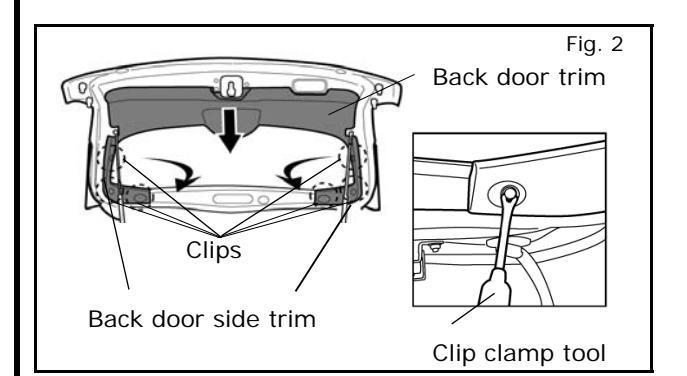
- a) Open Back door, and remove Back door trim.
- b) Remove of 3 clips on Back door side trim using clip clamp tool.

Be careful not to lose the clips as they will be used again.

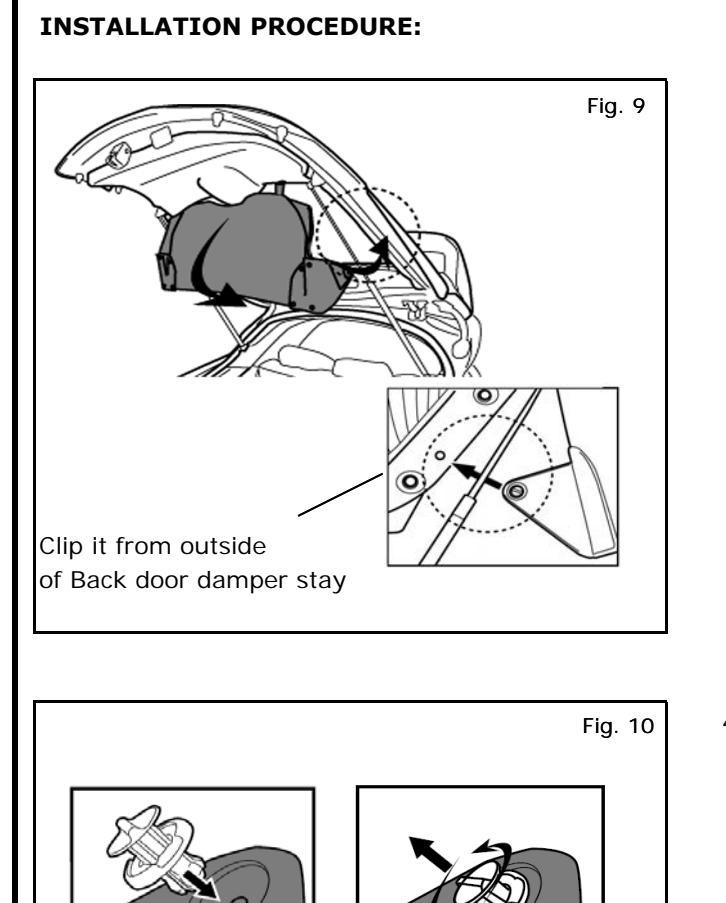
Remove

Install

d) Install Tonneau cover assy to back door side trim using the clips on both ends.

4) Removal of Tonneau cover assy from back door trim.a) When you remove tonneau cover, rotate and remove the clip.
