Instruction No	Version	Part. No.
30721883	1.1	30721881

Load compartment divider, longitudinal

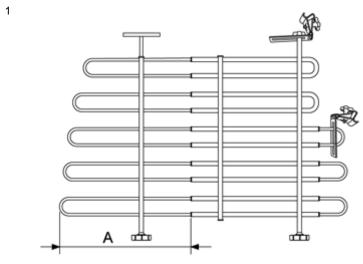
IMG-278991

Before installing, pull out/slide in the rear part of the cargo compartment separator so that dimension A is 430 mm (16 15/16").

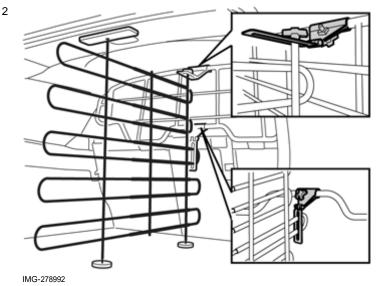
2

Position the cargo compartment wall with the clamps into the car.

Open the upper clamp and affix it loosely on the top bar of the safety grille.

Open the lower clamp and affix it as illustrated. Tighten the clamps only exactly as much as necessary to grip the grille, do not tighten them yet.

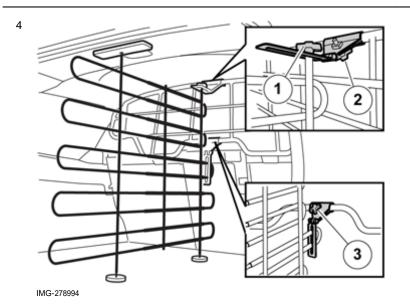
3

Adjust so that the cargo compartment wall is vertical and in the centre of the cargo compartment.

Screw the support panel (1) so that it is against the roof panel, and is parallel with it.

Screw down the rear support foot (2) so that the cargo compartment wall is tensioned.

Screw down the front support foot (3) so that the cargo compartment wall stands in a straight, vertical position.

Tighten the knobs (1-3).

Check that the cargo compartment wall does not make contact with the tailgate when it closes.
